Karle, K.F., and R.V. Densmore. 2001. Results From a Channel Restoration Project: Hydraulic Design Considerations. In proceedings: 2001 Wetlands Engineering and River Restoration Conference, American Society of Civil Engineers, Reno, NV. August 2001.

Results From a Channel Restoration Project: Hydraulic Design Considerations

Kenneth F. Karle* and Roseann V. Densmore**

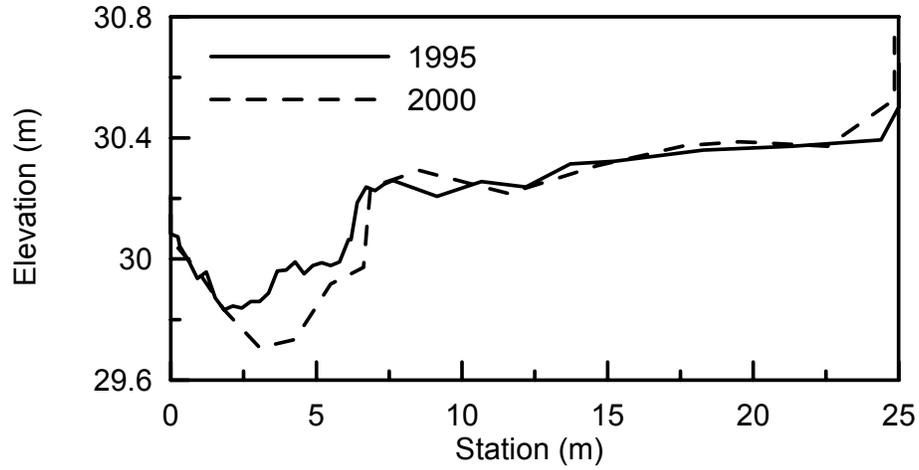
Figure 2. Cross-section 1, Glen Creek, Alaska.

Cross-sections 1 and 2 are located in the upstream reach of Section 1. Though the floodplain through this area was entirely inundated by the flood, channel geometry changes were insignificant in the upper reach of Section 1, as shown by Cross-section 1 (Figure 2). However, severe bank erosion, thalweg migration, and brush bar destruction occurred just downstream of this reach (Cross-section 2, Figure 3).

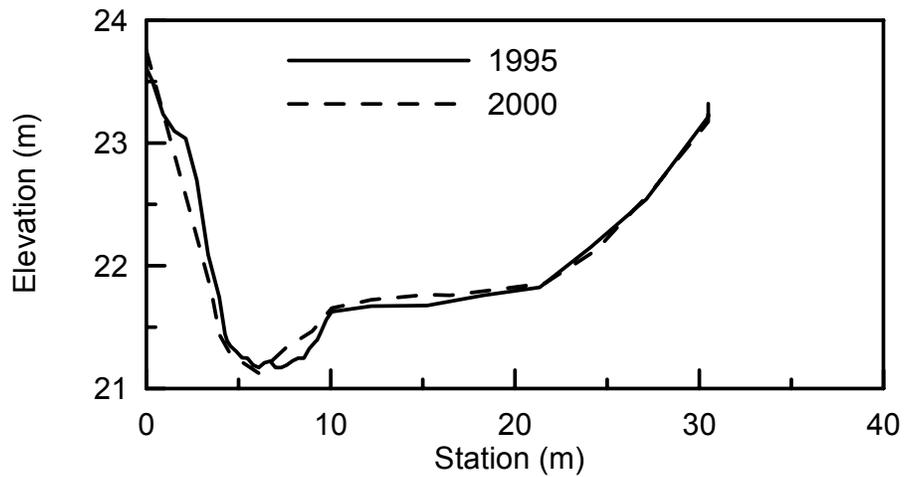
Figure 4. Cross-section 8, Glen Creek, Alaska.

In the lower reach of Section 1, channel changes were much less severe. Cross-sections 8 and 10 (Figures 4 and 5) display only moderate changes between 1995 and 2000.

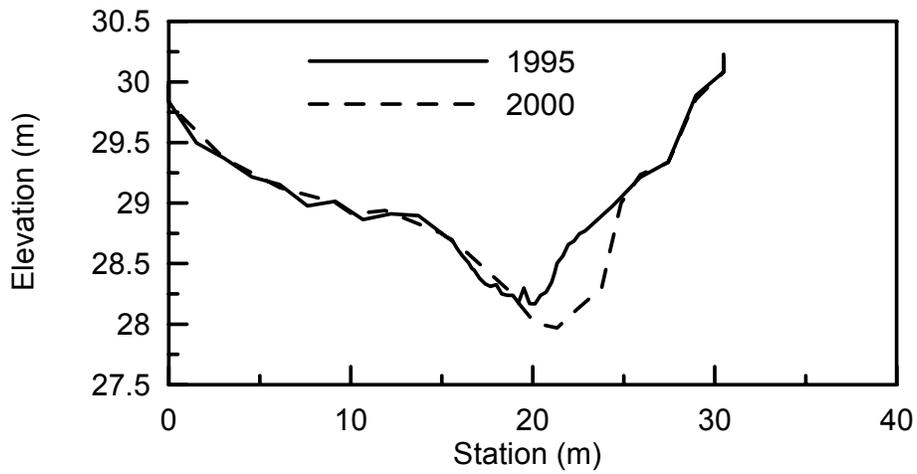
Figure 6, Cross-section 12, Glen Creek, Alaska.

Changes to the channel and floodplain geometry in Section 2 were substantial. Fifteen of the original 25 brush bars were partially or completely destroyed. Channel changes included extensive erosion of banks, displacement of the thalweg, and an increase in the width/depth ratio. Cross-sections 12 and 14 (Figures 6 and 7) are typical of the changes to channel and floodplain geometry throughout Section 2.

Our original design objective was to adjust channel geometry such that critical shear stress just exceeds average shear stress at bankfull discharge. To determine if we met that criteria in the field, we used the 1995 Cross-section 12 data along with the revised estimation of bankfull discharge to determine the average shear stress at channel design flow, using Equation 1:

At bankfull discharge, $R = 1.07$ m, $S = 0.0212$ m/m, $\gamma = 1000$ kg/m³, and $T_{0bed} = 22.6$ kg/m². This value substantially exceeds both our original and revised estimations of critical bed shear stress.

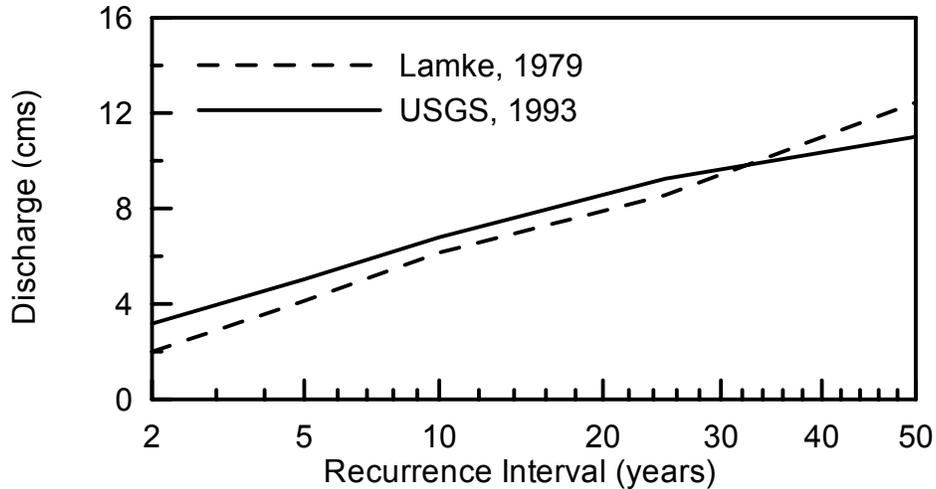
Figure 8. Original and revised flood frequency curves for Glen Creek study area.

The U.S. Geological Survey has published a more recent document to estimate flood magnitudes and frequencies in Alaska (USGS, 1994). Based on basin climatic and physical characteristics and peak-flow statistics from 260 gaged locations in Alaska and 72 gaged locations in Canada, this report divides the State into five flood-frequency areas having similar characteristics. Using such basin characteristics as drainage area, mean annual precipitation, mean basin elevation, mean minimum January temperature, and area of lakes and ponds, new estimations of design flows were calculated using the 1993 report. Comparisons using the two methods are shown in Figure 8.

We estimated bankfull discharge by interpolating a 1.5-year flood from the original flood frequency curve, and adding 25% as a factor of safety (1.83 m³/s). A safer estimation technique would be to use the 2-year flood from the 1993 report as the bankfull discharge (3.18 m³/s).
